BERNINA Firmware Release

BERNINA 7- series

V 32.43.10

Steckborn, 25th October 2012

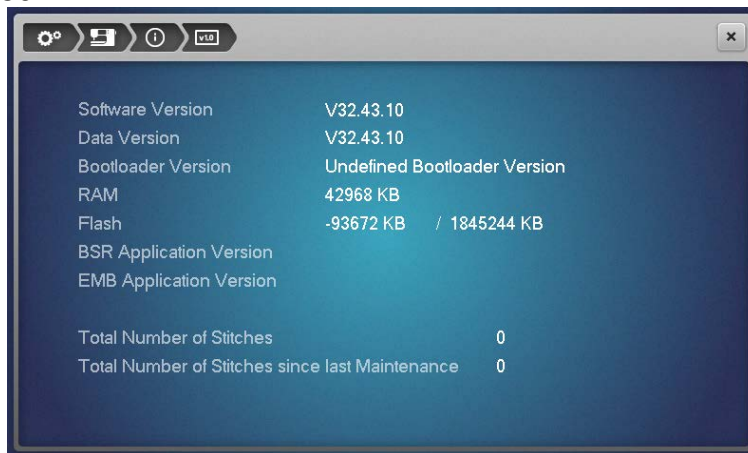
B 780:

- 1.) Unexpected machine stop
The machine stop in sewing and embroidery mode has been corrected.
- 2.) Thread tension for stitches 1+2
The thread tension for the straight and zig-zag stitch (stitches 1+2) has been optimized.
- NEW
- 3.) A “sidestep” has been integrated in the thread cutter which is activated automatically after having completed the sewing function. The thread cutter performs a sideways step (below 1.0mm) to the left to avoid a thread cluster on the wrong side of the fabric.
- 4.) Flickering screens at B710 or B750
in case of flickering displays, the new firm ware helps. The clock rate has been increased to control the LCD-tolerances.
